INTEGRATED VIDEO CALIPER COMPLETION FAILURE DIAGNOSIS IN HORIZONTAL WELL

MULTI-STAGE HYDRAULIC FRACTURING

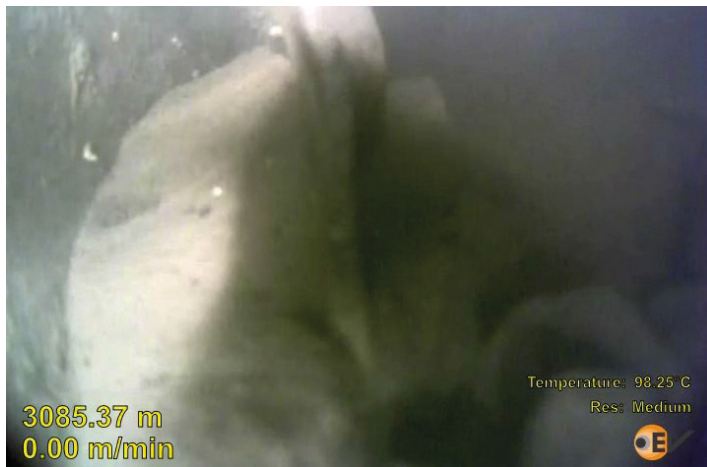
Downview video footage identified the location of, what appears to be, a catastrophic liner failure above an open-hole packer. The nature and extent of the damage was such that the toolstring could not pass this depth and therefore neither the caliper nor sideview camera alone could have identified the problem.

The deformation analysis provides an understanding of the pipe failure mechanism and one can theorise that a similar level of pipe deformation across deeper stages may have compromised the mechanical integrity of the pipe. This most likely led to a reduced collapse resistance due to the induced ovality from the deformation.

Figure 3: Downview image of obstruction believed to be collapsed liner

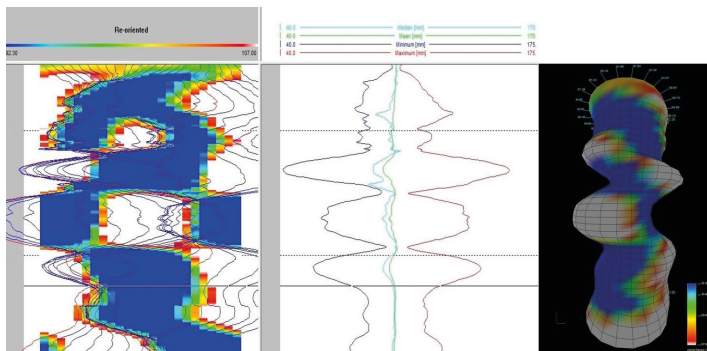
The multi-finger caliper data identified a number of concerning regions of pipe ovality and buckling across the logged interval. This buckling helps to explain the access issues experienced during the milling operation and is confirmed by the drift simulation carried out via Epidote's PDA. The drift simulation goes even further and advises the maximum length and diameter of rigid assembly that would successfully pass through this section.

Figure 4: Buckled liner section illustrated from minimum and maximum multi-finger traces and 3-D well plot
