OPTIS™ HD ELECTRIC LINE SHEDDING LIGHT ON FRACTURE EFFICIENCY

EV's electric line side view camera sheds light on perforation performance and fracture efficiency

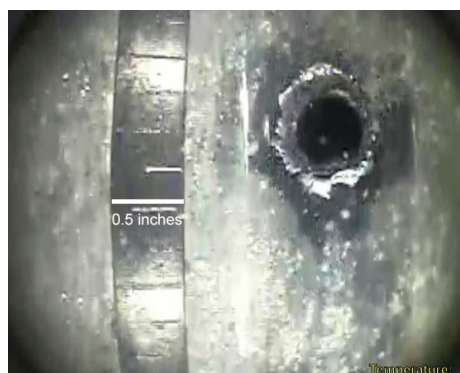
Area=0.15 in²

Figure 1: Example of perforation area pre (left) and post (right) hydraulic fracturing

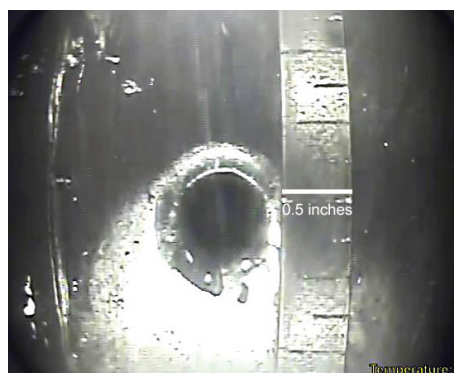
Area=0.307 in²

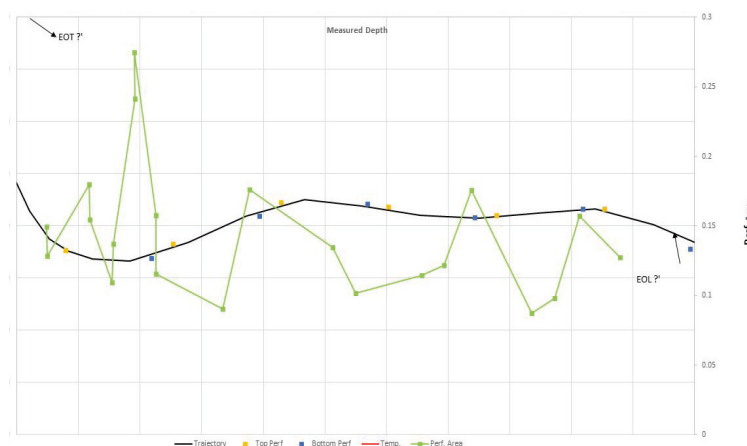
Figure 3: Pre-fracturing perforation area plotted along wellbore trajectory
