OPTIS™ MEMORY HD IMPROVING INTERVENTION OPERATING EFFICIENCY

EV's memory camera provides valuable insight to assist with complex fishing operation

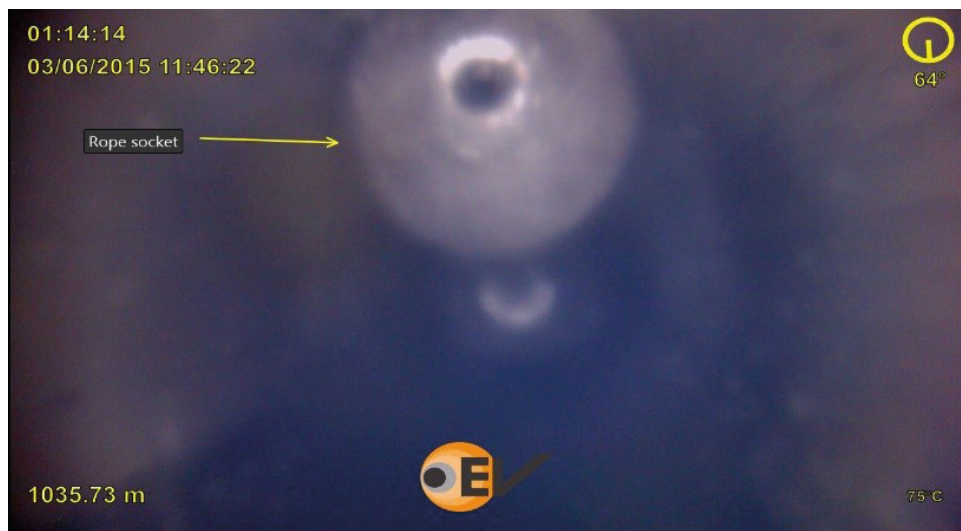
Figure 1: Drop bar fishing neck sitting on the low side of the wellbore and located at 1035 m

After identifying the top of the wire, approximately 255 m of slickline cable was retrieved. The next task was to locate the depth of the drop bar and cutter left in the well from the previous intervention. A single camera run successfully located the drop bar fishing neck (Fig 1) sitting on top of the side wall cutter (Fig 2). The orientation and position of each fish was established from these images which, in turn, determined the design of the appropriate fishing string. The items were successfully retrieved along with a short section of slickline cable identified on a following run (Fig 3).

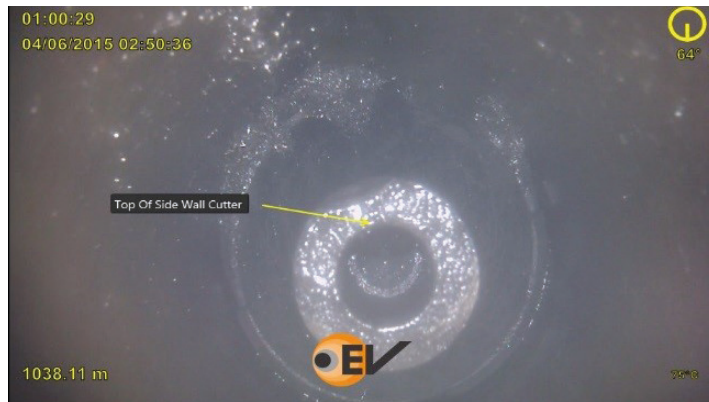
Figure 2: Side wall cutter seen centralised in the well at 1038 m

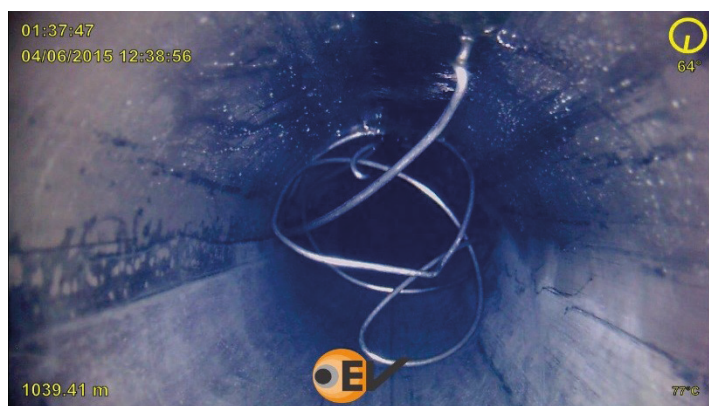
Figure 3: A short length of slickline cable located below the cutter after its successful retrieval

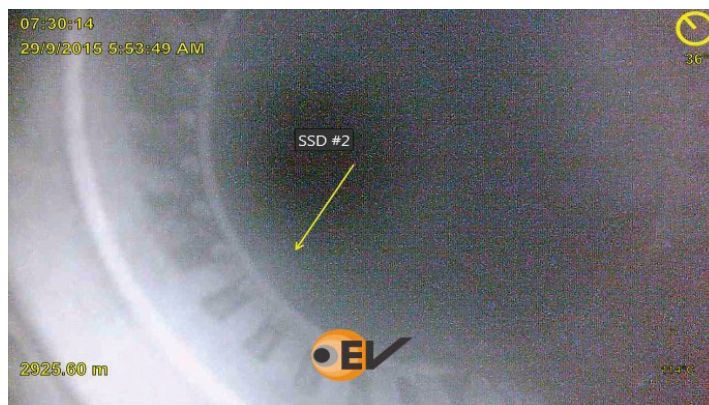
The position of the sliding sleeve was confirmed a few months later during a coil tubing intervention after the shifting tool had been pushed further down the well (Fig 4).

Figure 4: Confirmation of SSD#2 open position during a coil tubing intervention in treated sea water
