INTEGRATED VIDEO CALIPER

SAFETY VALVE FAILURE DIAGNOSIS IN HIGH TEMPERATURE WELL

EV's Integrated Video Caliper (IVC) tool identifies failed safety valve and evaluates seal bore condition

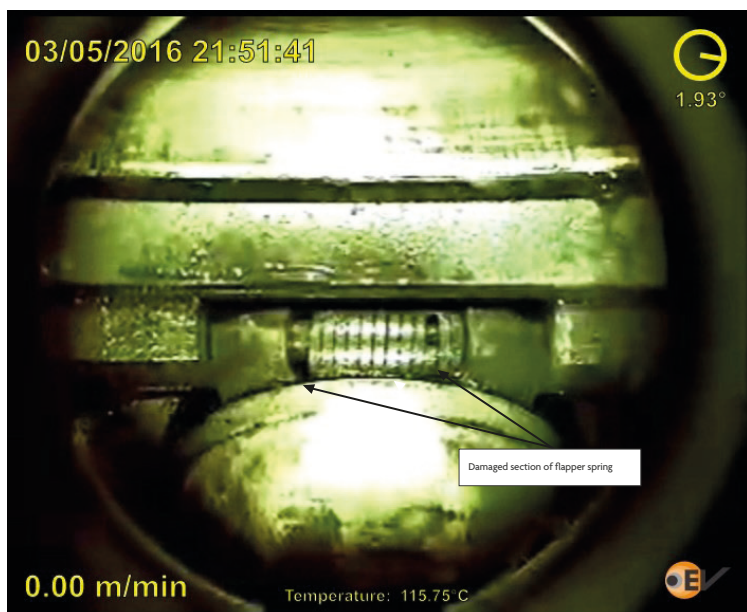
The sideview image in Fig 1 shows the damaged spring assembly which prevented the flapper valve from closing as expected. Prior to the camera being run, a number of possible reasons were under consideration. Visual clarification eliminated any uncertainty.

Figure 1: Damaged Flapper Valve Spring

EV's high definition, colour sideview camera clearly identified damage to the safety valve spring and hence the reason why the flapper did not close. The camera also revealed scratch marks on the lower seal bore. These images along with quantitative data from the multi-finger caliper provided valuable information about the internal condition of the safety valve so that future interventions could be planned.

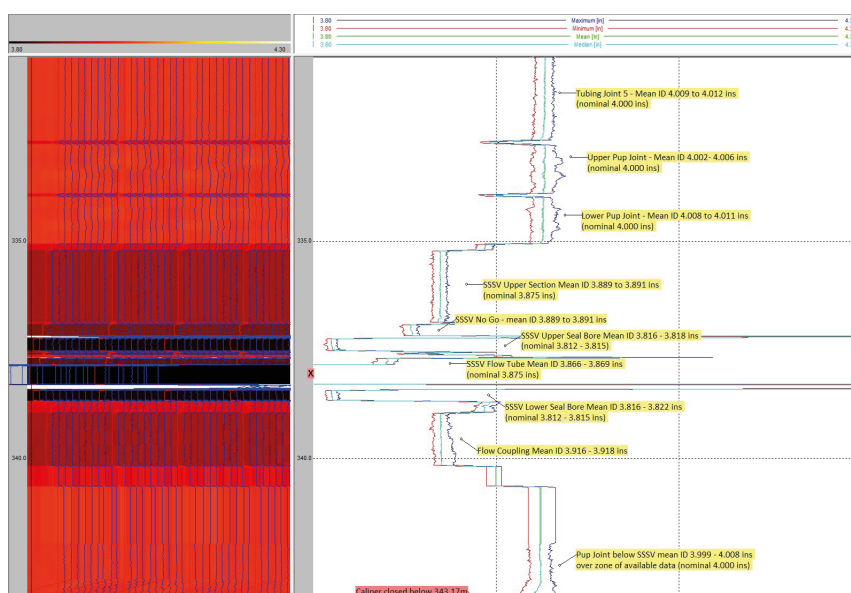
The service does not stop there. A full integrated video and multi-finger caliper interpretation was provided where further sideview images were integrated into the analysis. Fig 2 provides a graphical display of the various components in the safety valve assembly and their measured and expected nominal inner diameter. Fig 3 shows a visual image of the internal condition of the lower seal bore alongside quantitative caliper data. While the mean inner diameter on the multi-finger caliper data is close to nominal, the sideview camera image clearly shows thin scratches on the inner pipe wall.

Figure 2: Dimensional data from MFC40 showing internal profile of safety valve assembly

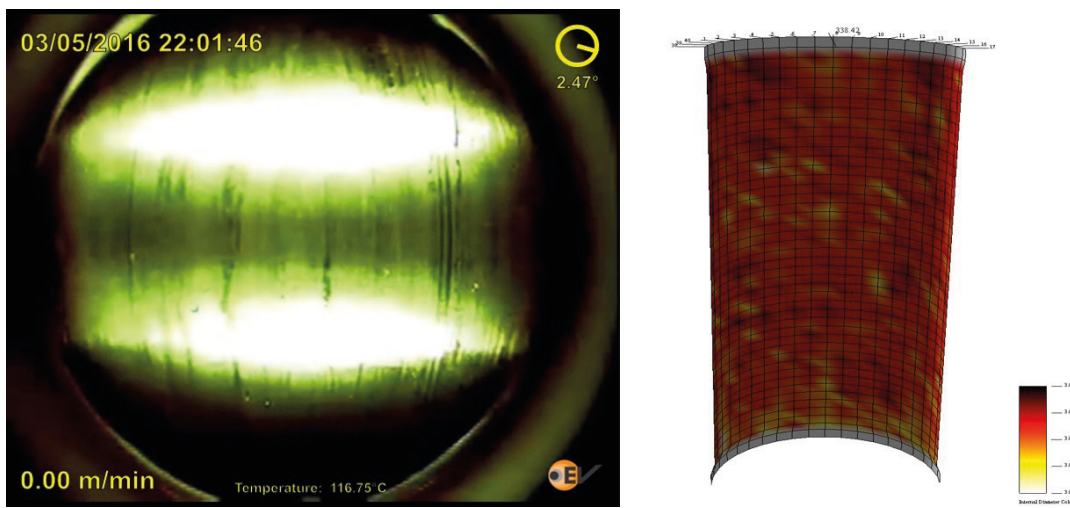
When the safety valve in a high temperature, offshore, gas producer failed to close, the customer issued a reinstating programme. However, when this failed due to unexpected pressure leak offs at the lower seal bore, the well was isolated until further information could be gathered and a comprehensive way forward determined.

Figure 3: Sideview image showing scratches in lower seal bore (left) and cross section of multi-finger caliper data across the lower seal bore (right)
