## OPTIS™ MEMORY HD

### VISUAL INTERVENTIONS BRING WELL BACK TO LIFE

EV's Memory Camera helps to avoid costly well work-over.

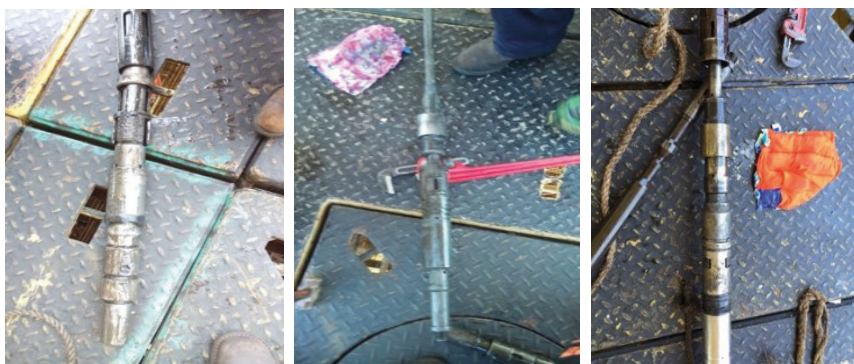
Shut-in wells can lead to deferred production, well integrity issues and increased cost for remedial work. This was the case for an operator in S.E Asia with one particular well shut-in and containing three separate fish (Fig 1).

Figure 1: Fish left in hole: W Slip Lock (left), Bulldog Spear (centre), B7 (right)

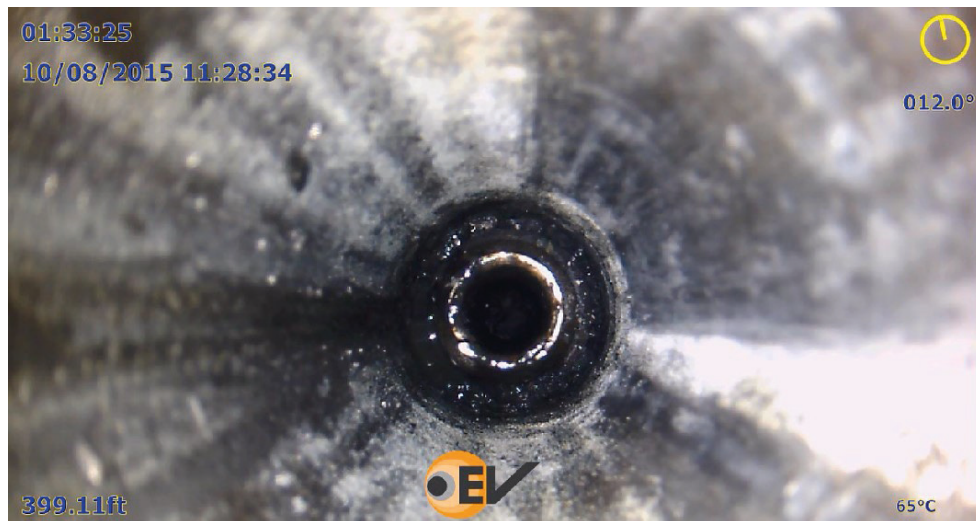
The acquired video and images showed the W Slip Lock at a depth of 400 ft (Fig 2.). The clear images and confirmed fish position renewed interest in a more tailored fishing campaign.

The top of the fish was clearly identified as the W Slip Lock. This enabled the customer to modify the standard fishing assembly and successfully retrieve the items from the well. The result was that the well was brought back online at 1350 bopd and an expensive work-over was avoided.

Figure 2: Top of W Slip Lock at 400 ft

Thanks to conclusive images and insight from the Optis™ Memory HD camera, all three fish were successfully retrieved from the well during a slickline operation spanning 22 days.

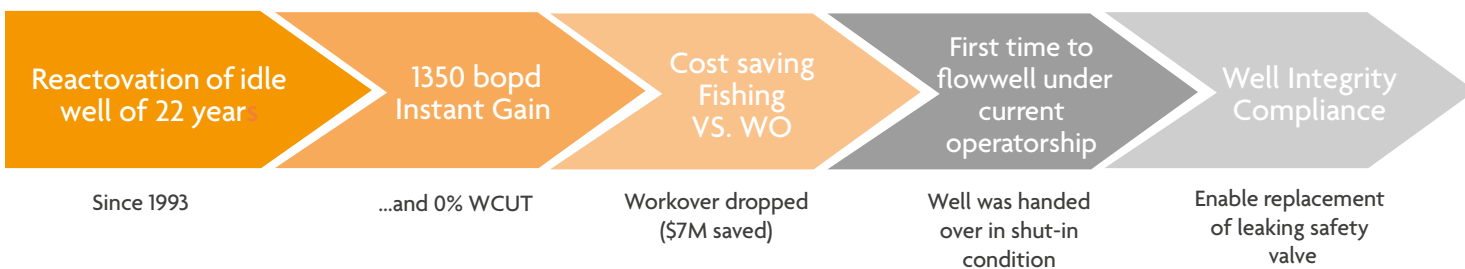
This example provides clear evidence of the value added when EV's solutions are included as an integral part of planned intervention activities. Rather than proceeding with the work-over, the customer decided to visually inspect the condition of the fish to assess if a more intelligent fishing campaign could be designed. The investment paid off and not only was an estimated \$7 million saved, by avoiding a work-over, but well production came on-line over target at 1350 bopd (Fig 4).

Figure 4: Results of successful intervention including significant cost savings compared to planned work-over
