INTEGRATED VIDEO CALIPER COMPLETION FAILURE DIAGNOSIS IN HORIZONTAL WELL

MULTI-STAGE HYDRAULIC FRACTURING

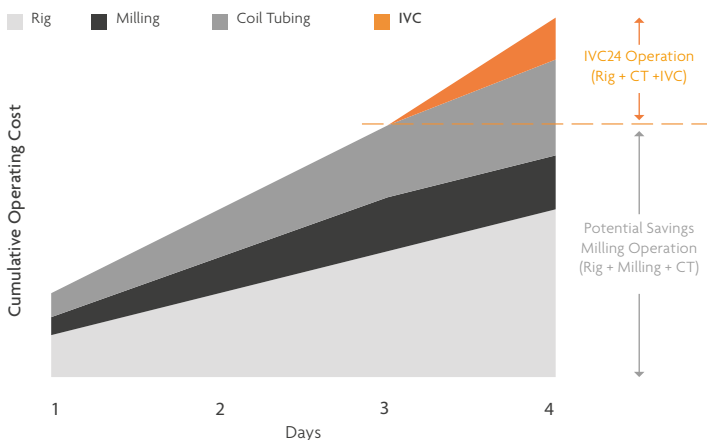
Figure 5 represents the total cumulative costs incurred during the operation, highlighting EV's potential to contribute to significant cost reduction. Had the operator elected to deploy the diagnosis solution sooner, cost savings would have been significant.

Figure 5: Graphic representation of cumulative costs and potential for cost savings
